The Clay Research Group

Edition 112

Issue 112, September 2014

The Aldenham Willow - Levels and Soils

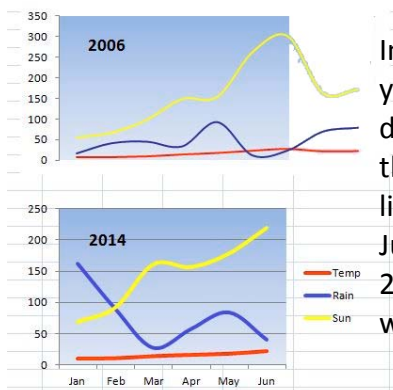
Weather Records

Weekly data from the Met Office for rainfall, temperature and hours of sunshine are shown below.

In 2006 (a surge year) rainfall dropped below the temperature line briefly in June. In contrast, 2014 was much wetter.

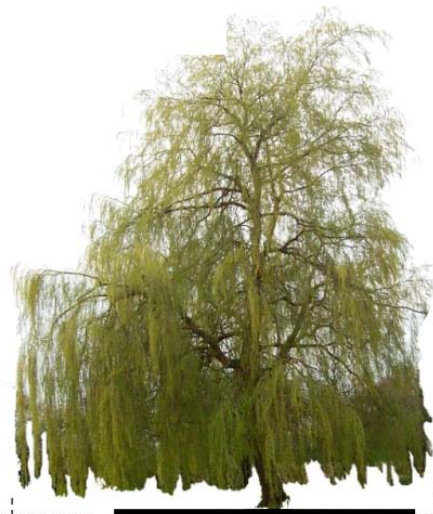
The estimates of heave from the filter paper test and oedometer strains are remarkably similar, differing only at BH1, 5mtrs from the tree. The heave potential here (in May 2006) was 100mm using the suction test, and 78mm using the oedometer.

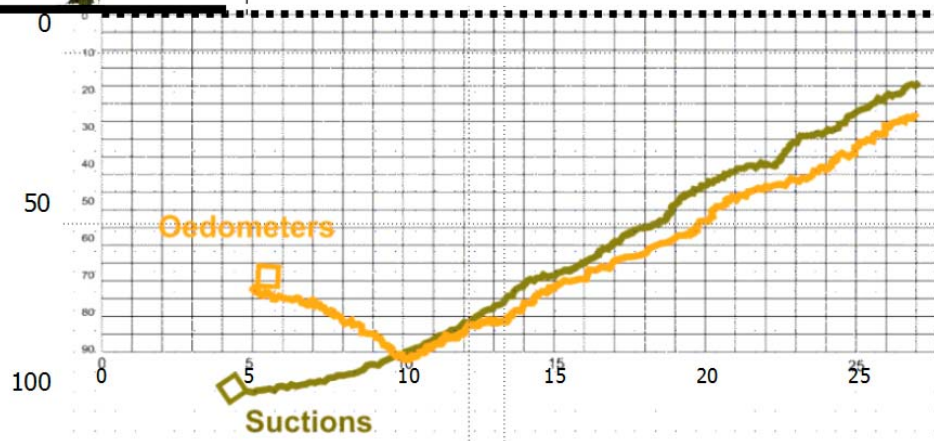
Estimated Root Induced Subsidence Profile - Aldenham Willow

Site Investigation - 25th May, 2006

There was less variance between the results further away from the tree, at the remaining boreholes. At BH2, the figures were around 90mm, BH3, 70mm and at BH4, some 25mtrs from the 14m high willow, the estimate was 30mm. See following page for values.

Inverting the figure from the previous page, the heave potential if the tree was removed.

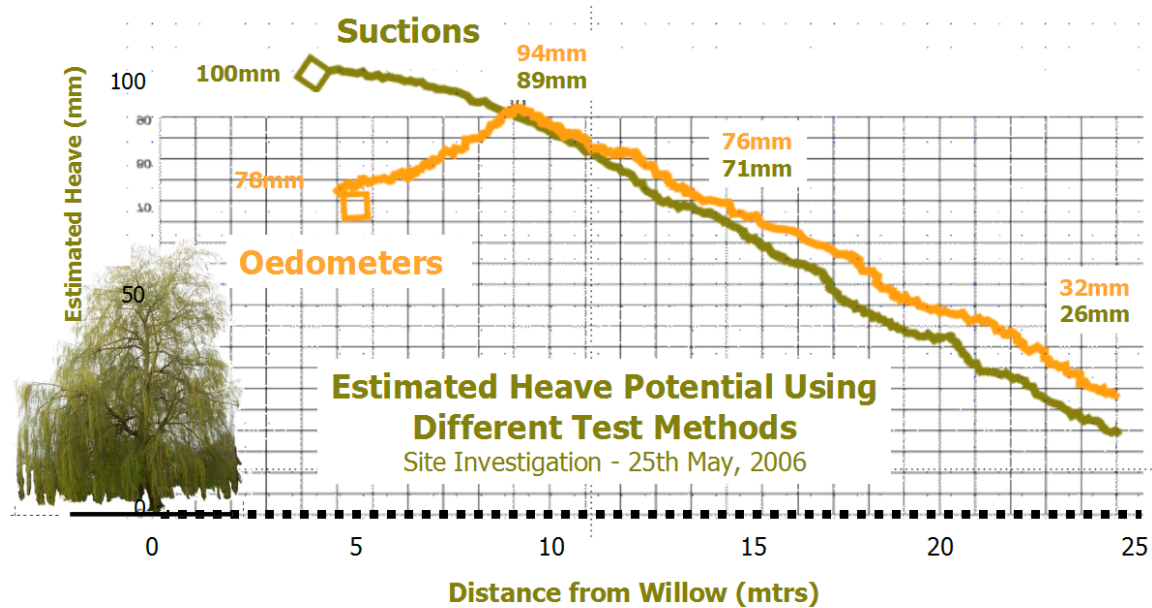
Looked at Another Way

Using the above values as a starting point, and adding movement recorded from precise levelling, it can be seen that furthest away from the willow, the deficit was say 30mm in May 2006, to which 60mm of seasonal movement would be added in the summer of 2013 = 90mm. Of the 90mm, around 20mm can be carried forward as a freshly developing persistent deficit, which means the ground ‘takes forward’ 50mm or so into 2014.

The ‘persistent’ element has been increasing steadily over the last 4 years, averaging 5mm per year. At a linear growth rate, it will take another 10 years or so to reach the levels of BH1. Assuming the roots have extended as far as they can go (25mtrs distance from a 14m high willow) and with very little knowledge of tree physiology, we can only assume it will be showing signs of stress shortly. Certainly suctions of 1,200kPa in late May must result in stress of the root zone closest to the tree.

That aside, a clear periodic signature has been evident even through fairly benign climatic years. The amplitude of seasonal movement is sufficient to cause damage to a domestic building.

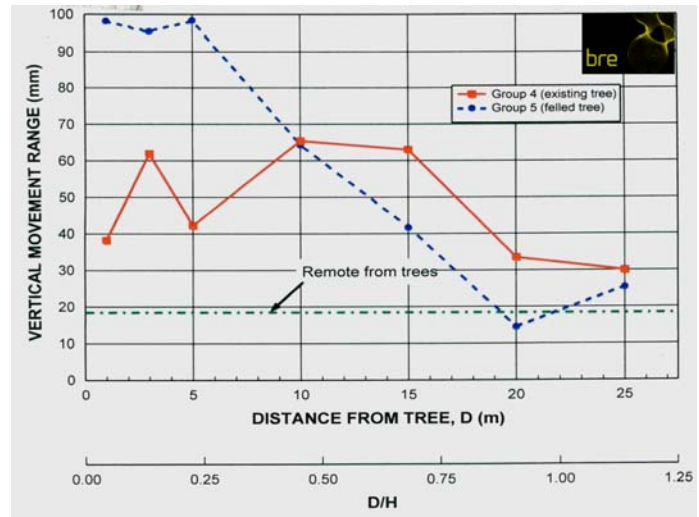
The Chattenden Study

Precise levels taken at Chattenden revealed the pattern of movement shown right. Ground movement in the vicinity of mature poplars was plotted, and again following their removal.

Levels at 5m intervals revealed 100mm of recovery near to the tree, diminishing with distance linearly until it expired altogether at a distance equal to the tree height.

Chattenden, Kent, is a site owned by the MoD. The BRE were granted access to undertake research on ground movement over a number of years in the vicinity of a number of mature poplar trees, with some remote stations acting as datums.
