The Clay Research Group

February 2018
Edition 153

Issue 153, February, 2018

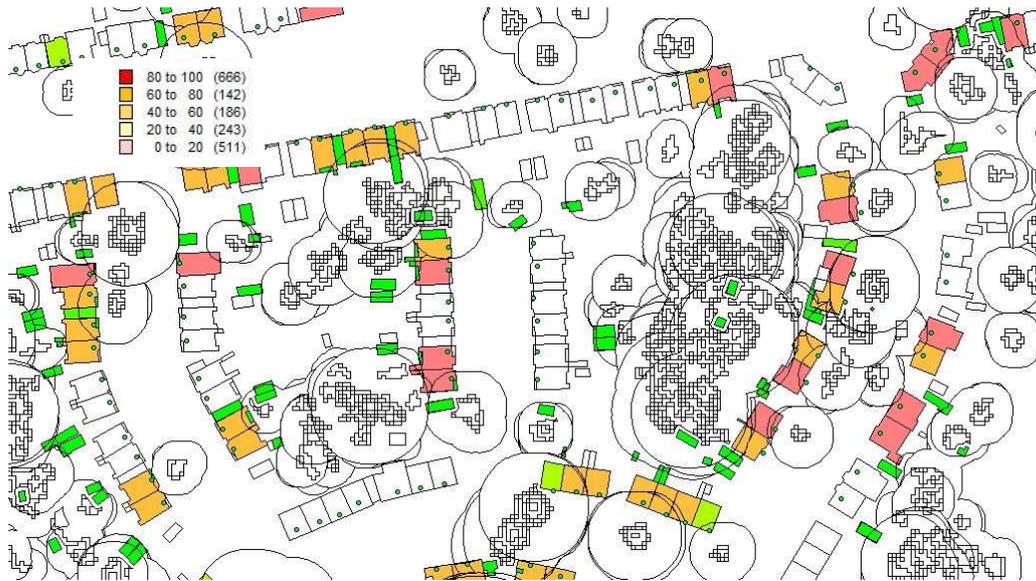
Thematic map showing properties rated according to the modelled root overlap. The map is for illustration purposes only and does not refer to the postcodes listed.

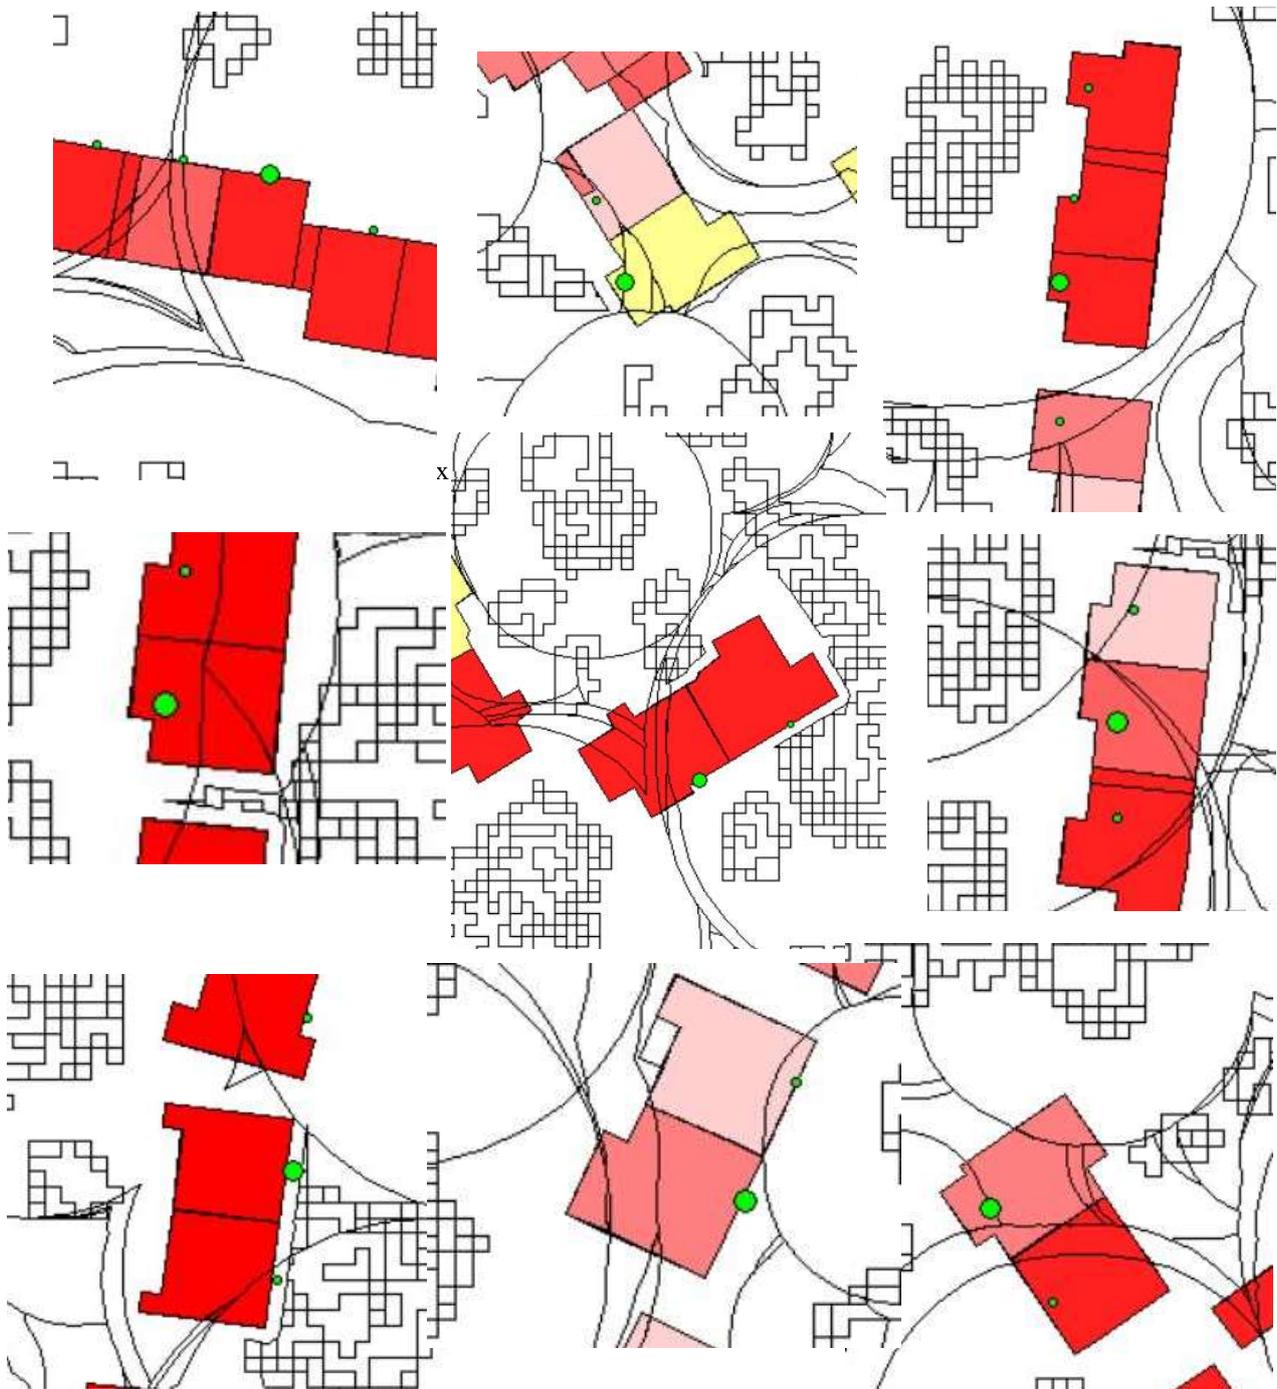
Study Area – NW11 6 – Valid Claims

A selection of claims correctly identified by the model as being at risk.

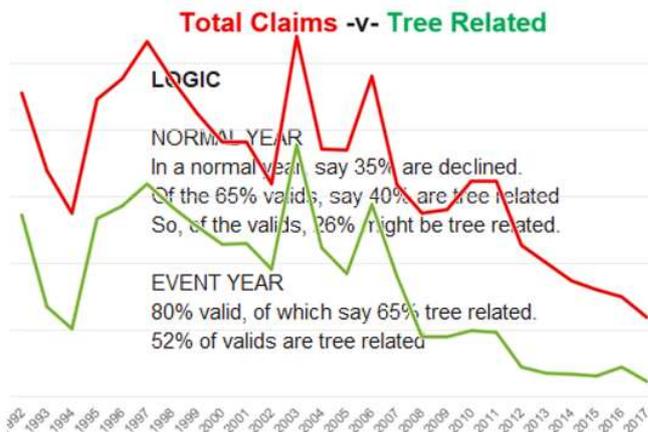
The red line plots claim numbers for the period 1992 – 2017. For our purposes, claims for the period 1971 to 1992 have been estimated at a reduced level, taking account of peaks in 1976 and 1984. The percentage of tree related claims is shown by the green line. A higher percentage of both valid and tree involved claims is linked to event years, and the number decreases in 'normal' claim years. An explanation of how tree related claim numbers have been calculated underlies the graph.

A deduction has to be made from the recorded claim numbers for declinatures and other perils - heave, escape of water etc. Taking these into account, our estimate is shown in the graph below. The calculation is based on 35% of claims being declined in a typical year plus a deduction for 'other perils', and in event years, that figures might be that 65% of valid claims are tree related from a total of 80% of valid claims recorded.

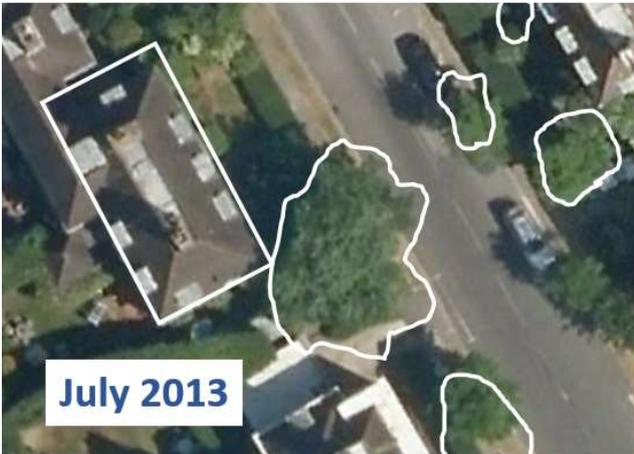
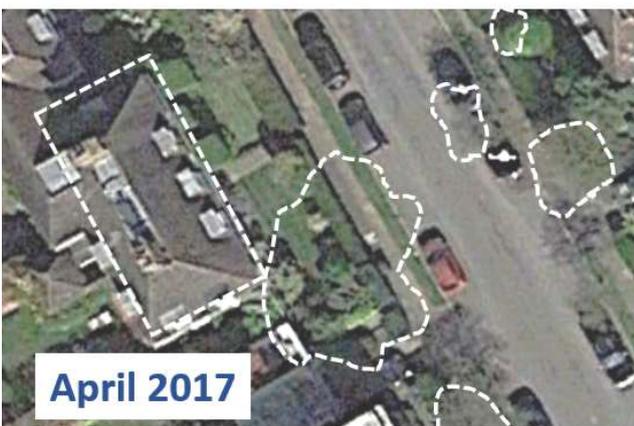
It may provide help when considering whether vegetation has been removed over recent years. In the case below, ‘current’ imagery shows no significant vegetation in close proximity to the property in April 2017.

In contrast, imagery from July 2013 reveals a large tree near to the property, as well as smaller vegetation across the road. By 2017, all had gone.
